FATIGUE EVALUATION OF NANOCOMPOSITES AS LIGHTWEIGHT
ELECTRONIC ENCLOSURES FOR SATELLITES' APPLICATIONS
THESIS

AFIT/GMS/ENY/09-M03

AIR FORCE INSTITUTE OF TECHNOLOGY

March 2009

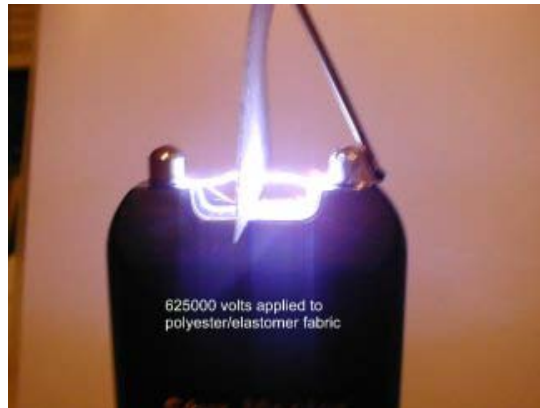
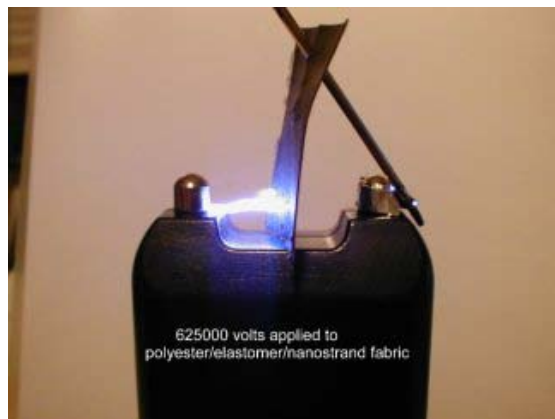
Figure 7. 625,000 Volt Discharge without Ni Nanostrands™

Matrix Composites Company of Utah have shown that even in low concentrations nanostrands™ provided sufficient conductivity to stop a 625,000 volt discharge. Figure 7 shows how a high voltage discharge easily penetrated an elastomer impregnated polyester cloth. In Figure 8, the same specimen with 5% nanostrands™ added was able to protect itself thanks to the conductive path provided nickel nanostrands™. The added nickel nanostrands™ on the M55J/RS3 material will be providing the needed electrostatic discharge protection for the safe employment of the composite in extreme environments.

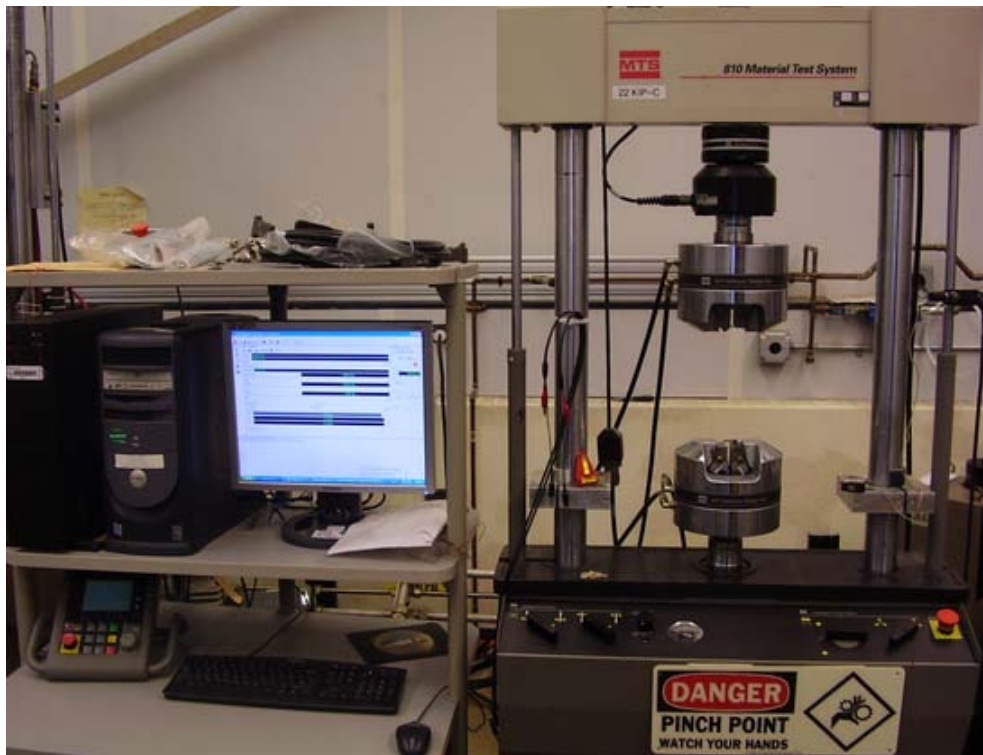
Figure 14. MTS 810 System

Before starting each test, a level was used to properly align the specimen in the vertical direction, with the purpose of avoiding the development of unwanted shear stresses into the material. After the specimen was properly placed and aligned, an extensometer was mounted on the specimen to record strain. An R ratio of 10 and a frequency of 10Hz were maintained for all stress levels. The required sets of cyclic loads, parameters and specifications were controlled by the Station Manager program. Figure 14 shows the MTS 810 system used for the fatigue testing.

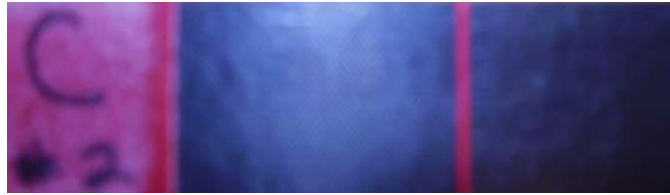
Figure 17. Red Mark on Specimen

After the machine was calibrated we proceeded to take measurements. In order to ensure that we kept a consistent and accurate reading process, a red or black mark was placed on the specimen. This mark was used to ensure next time we were making a reading we evaluated the exact same spot we were evaluating previously. Figure 17 shows a picture of a marked specimen, and Figure 18 shows the test set-up for this part.

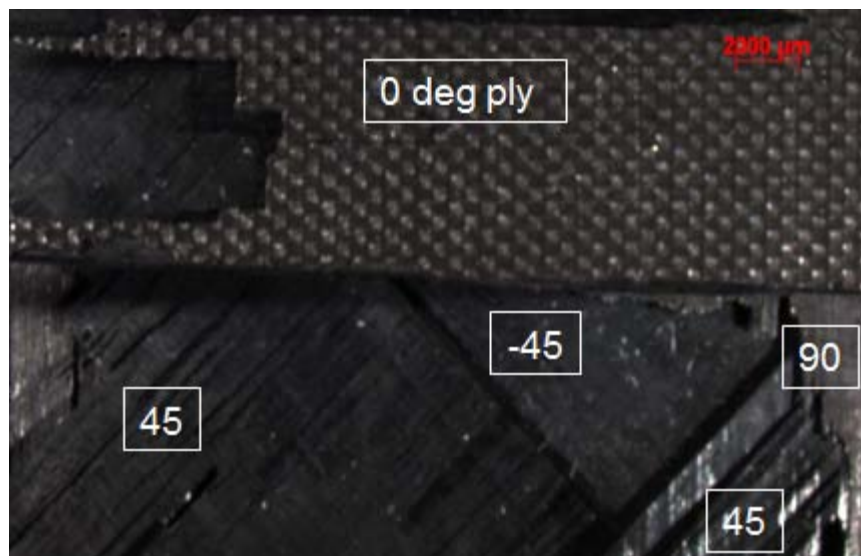
to the to the 0° ply, initiating damage in the 90° ply. The exterior specimen suffered delamination between the 0° and 90° plies, between 90° and 45° plies, and between the 45° and -45° , in different areas along the length specimen, but constrained its grow between individual plies. Shear failure of the specimen was observed as shown in Figure 46. Figure 47 shows the damaged stacking sequence. A closer look in Figures 48a and 48b shows delamination and the condition of nickel nanostrands after fracture.

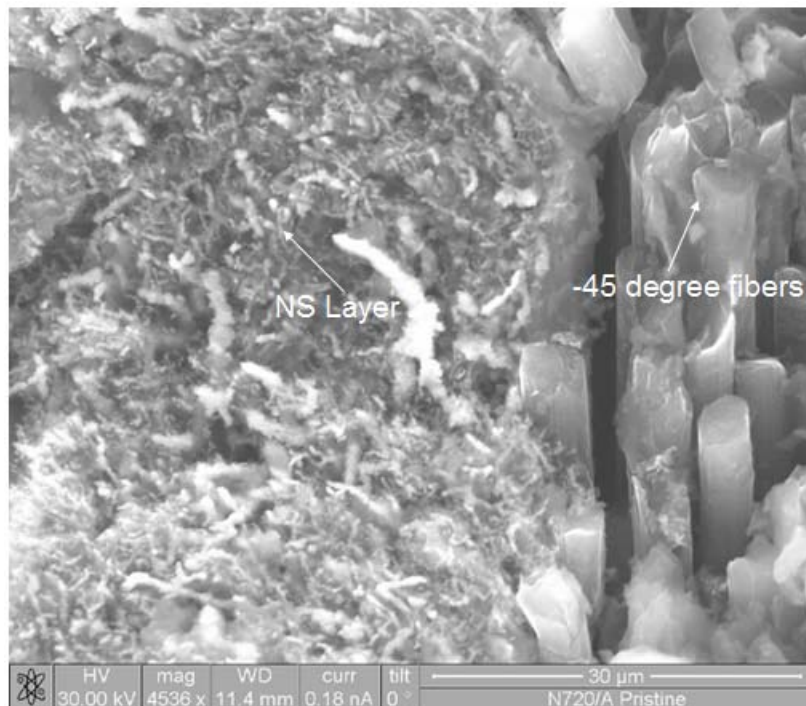
For the interlaminar specimen shown in Figure 49, as in the 60% UTS level, its delamination concentrated more between the 90° and 45° plies. Also, the 0° ply started to visibly crack after 1 million of cycles were applied. A closer look to the side of the specimen is presented in Figures 49 to 51, where delamination between the 90° and 45° plies is clearly seen. Figures 50 and 51 show how cracks propagated along the nickel nanostrandsTM layers without crossing or affecting them. Figure 52 shows a closer look of the area between the nickel nanostrandsTM layer and the -45° ply. Upon inspection, the nickel nanostrandsTM area seemed to be intact.
